# A CONDOMINIUM MAP OF THE VELO CONDOMINIUMS

SITUATED WITHIN LOT 1C, AIRPORT SOUTH REPLAT C, A SUBDIVISION LOCATED  
IN THE SOUTHEAST 1/4 OF SECTION 21, TOWNSHIP 1 NORTH, RANGE 70 WEST OF THE 6TH P.M.,  
CITY OF BOULDER, COUNTY OF BOULDER, STATE OF COLORADO  
SHEET 2 OF 4

## BUILDING C DETAILS - 3281 AIRPORT ROAD

BOULDER LAND  
CONSULTANTS, INC.

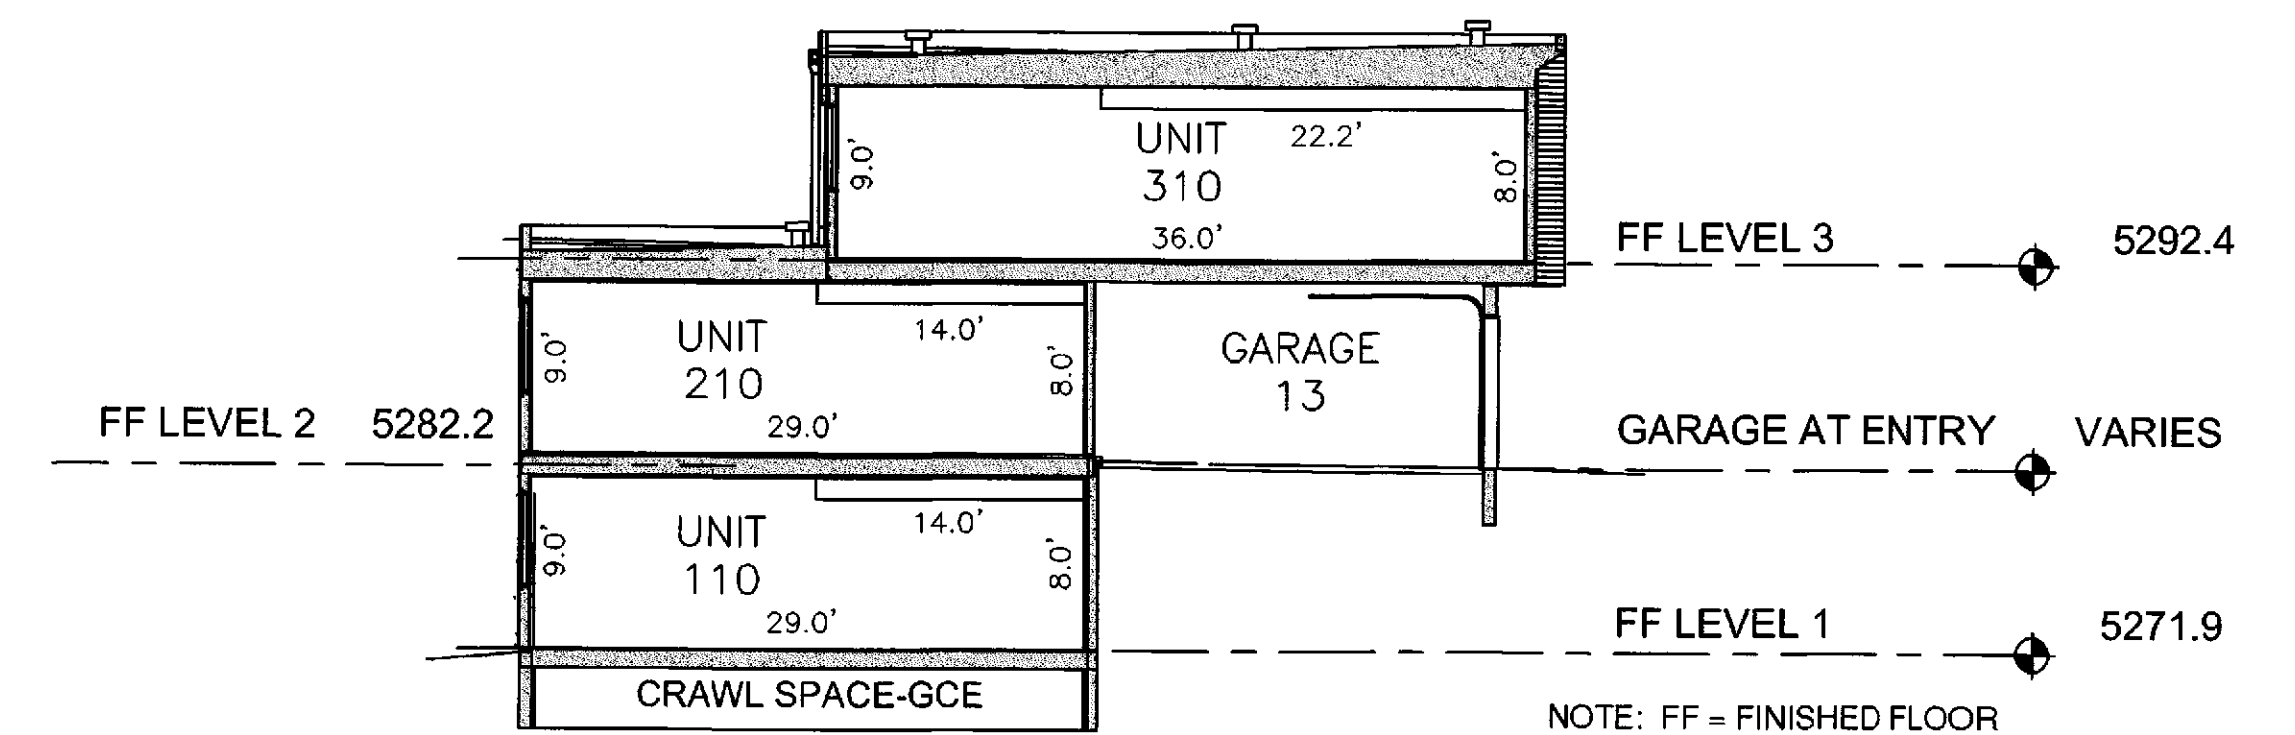
## BUILDING C

WEST-EAST CROSS-SECTION, LOOKING NORTH (NO INTERIOR WALLS SHOWN)

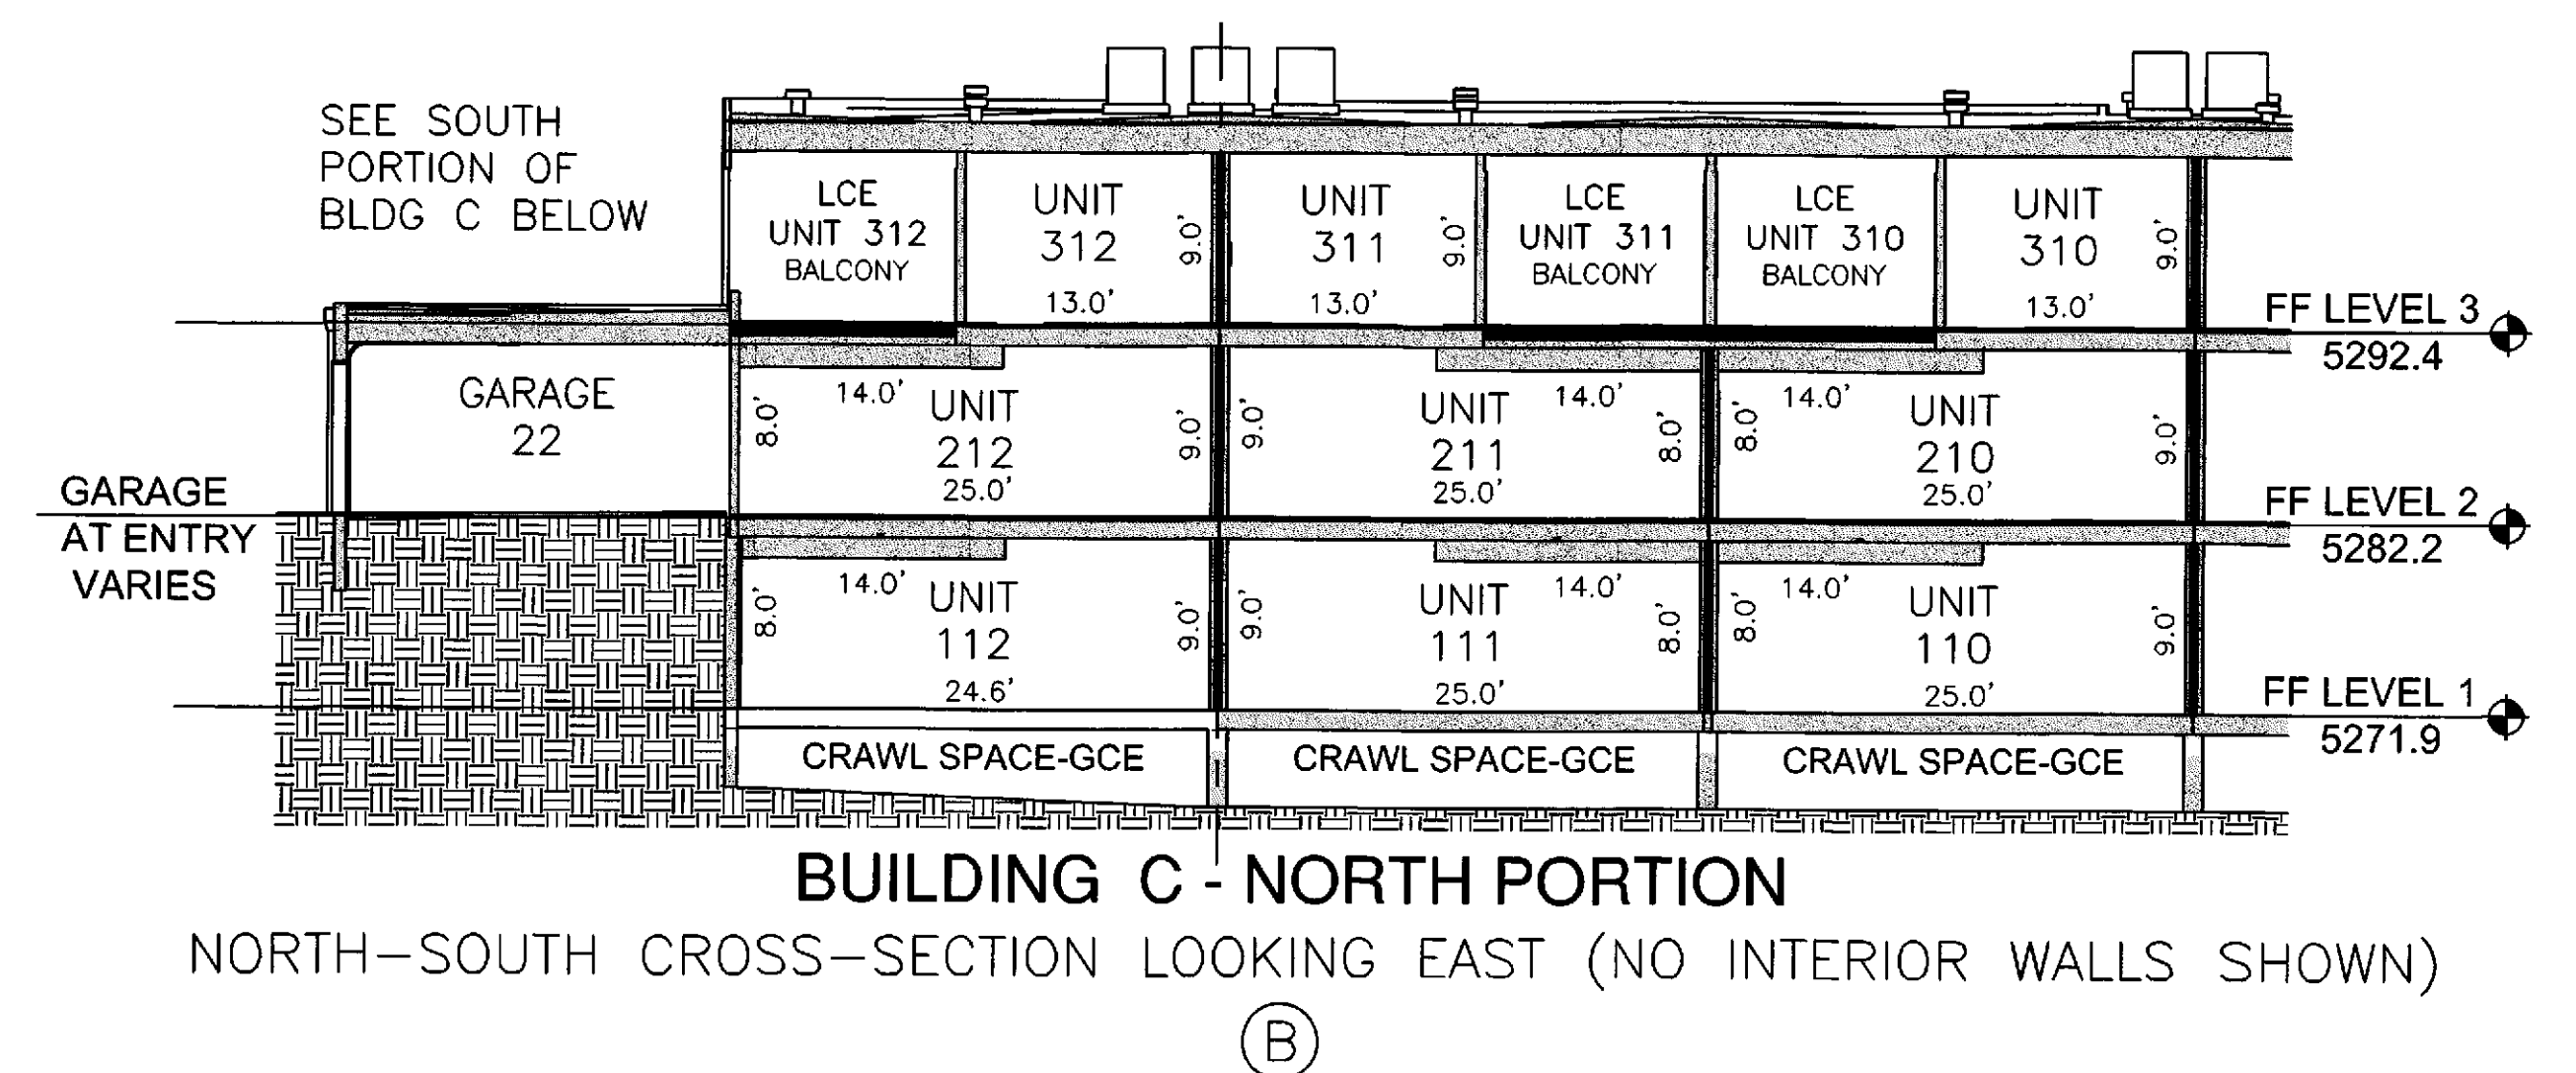
BUILDING C - NORTH PORTION

NORTH-SOUTH CROSS-SECTION LOOKING EAST (NO INTERIOR WALLS SHOWN)

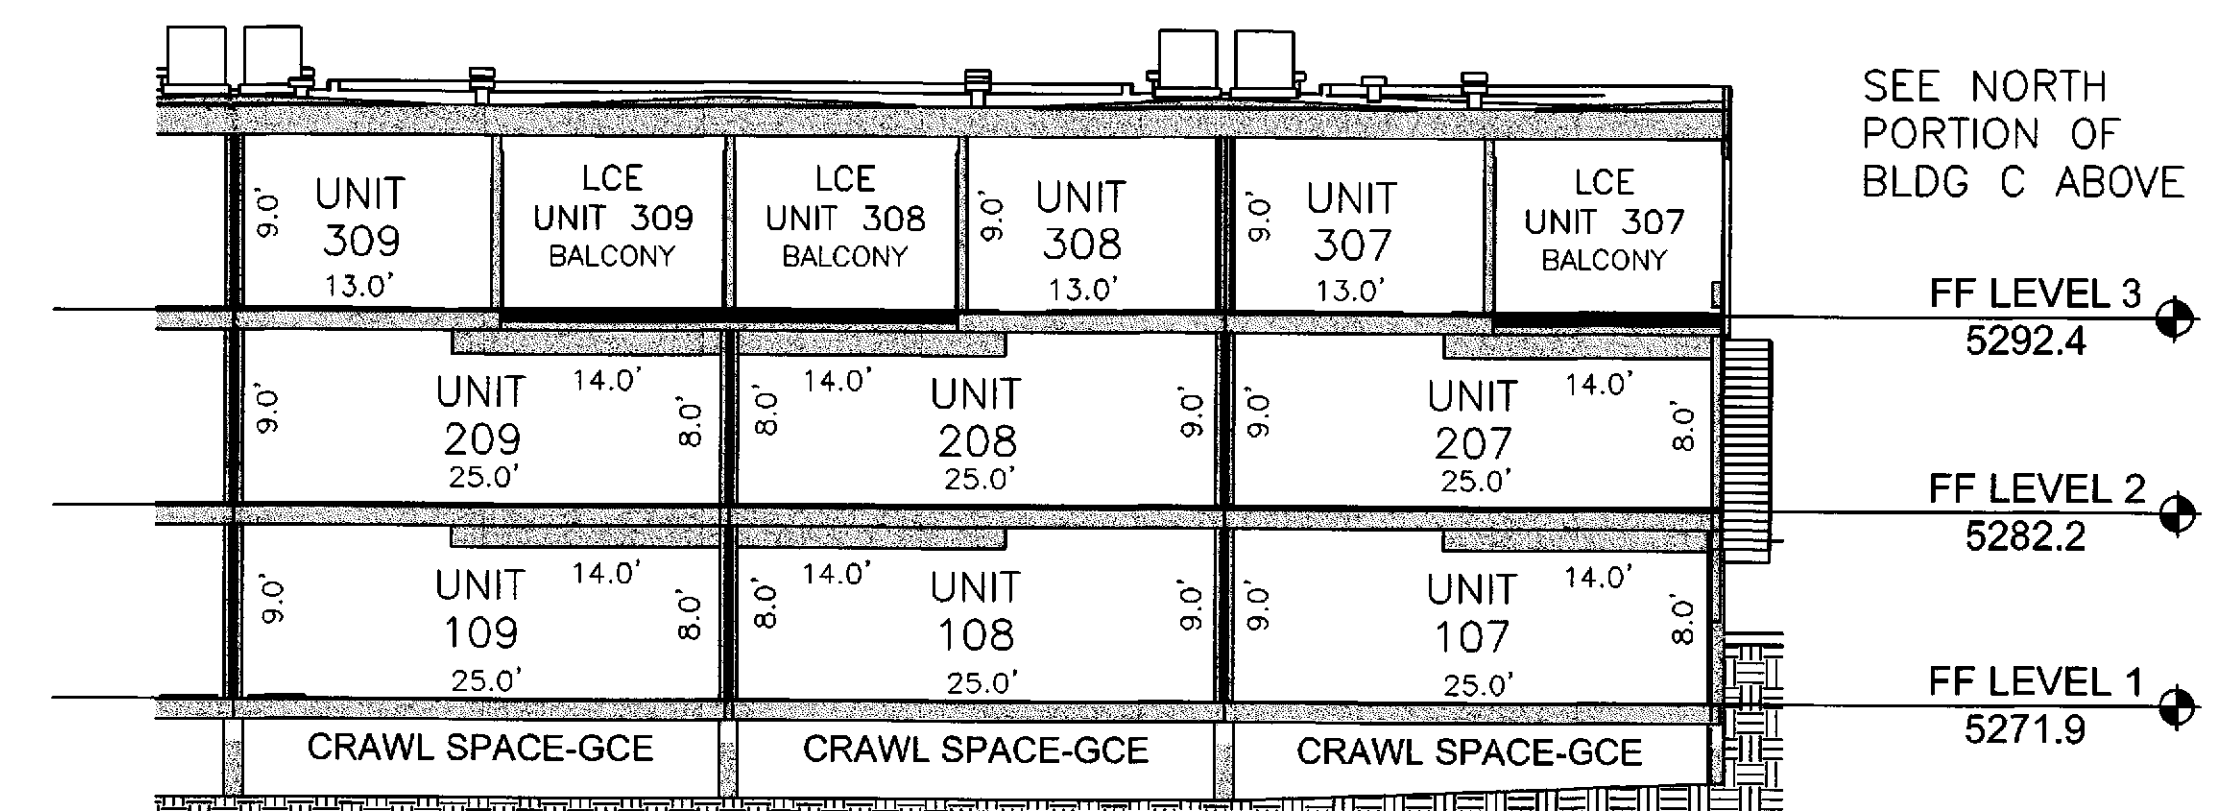
## BUILDING C - SOUTH PORTION

NORTH-SOUTH CROSS-SECTION LOOKING EAST  
(NO INTERIOR WALLS SHOWN)

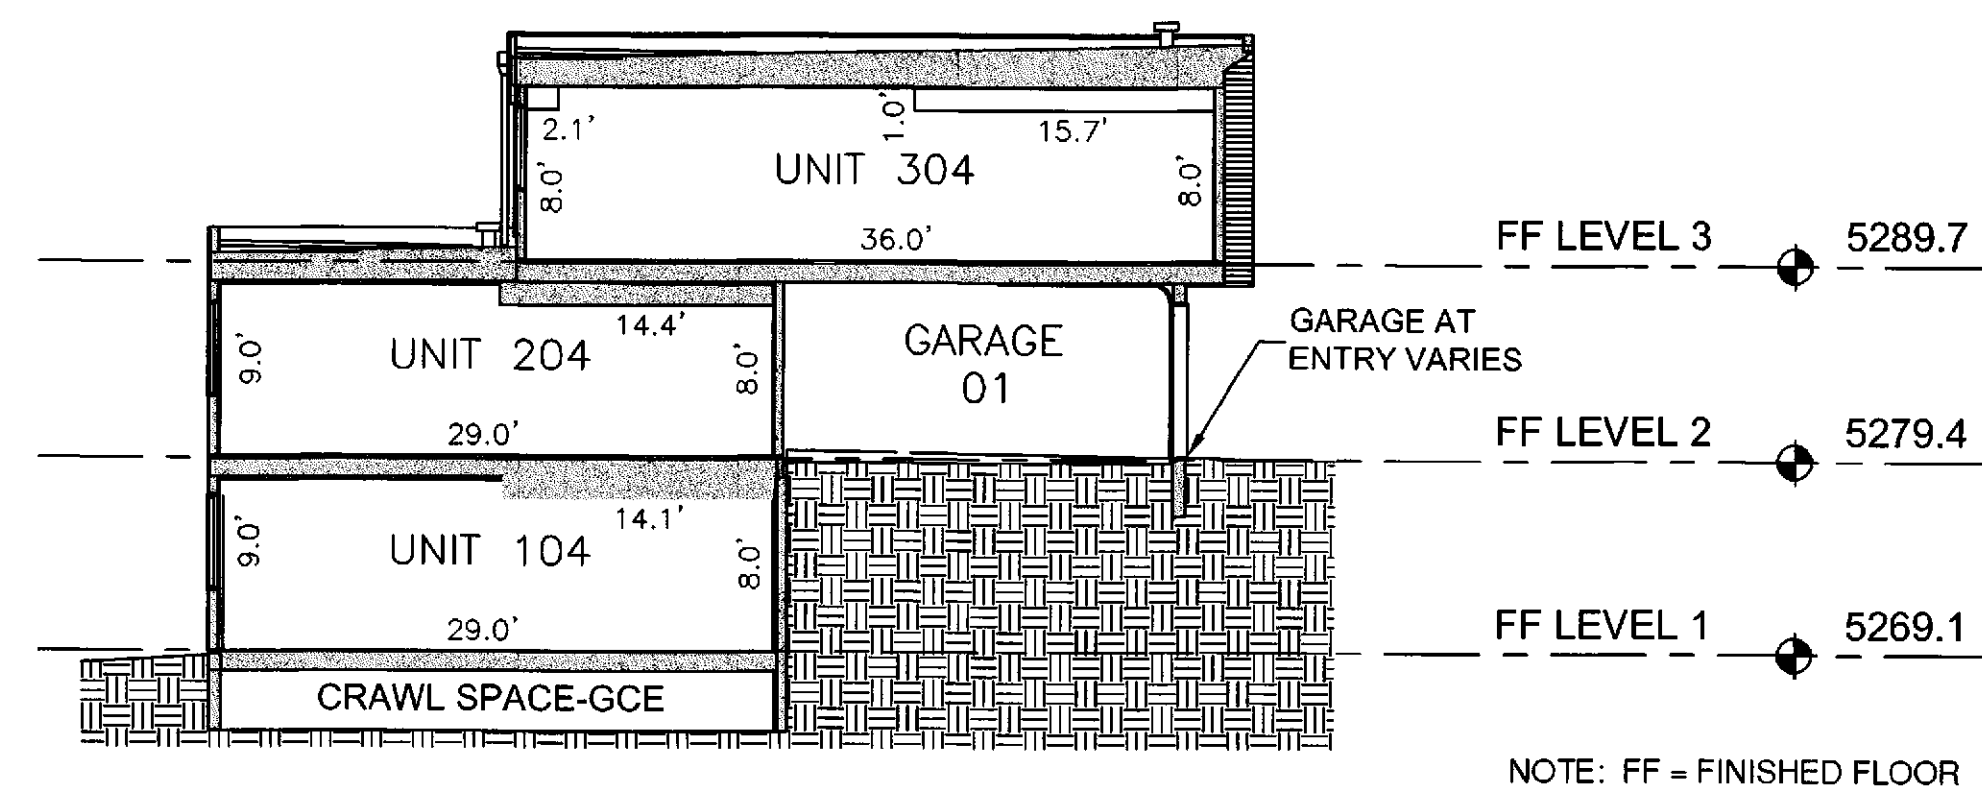
**BUILDING D**

WEST-EAST CROSS-SECTION LOOKING NORTH  
(NO INTERIOR WALLS SHOWN)

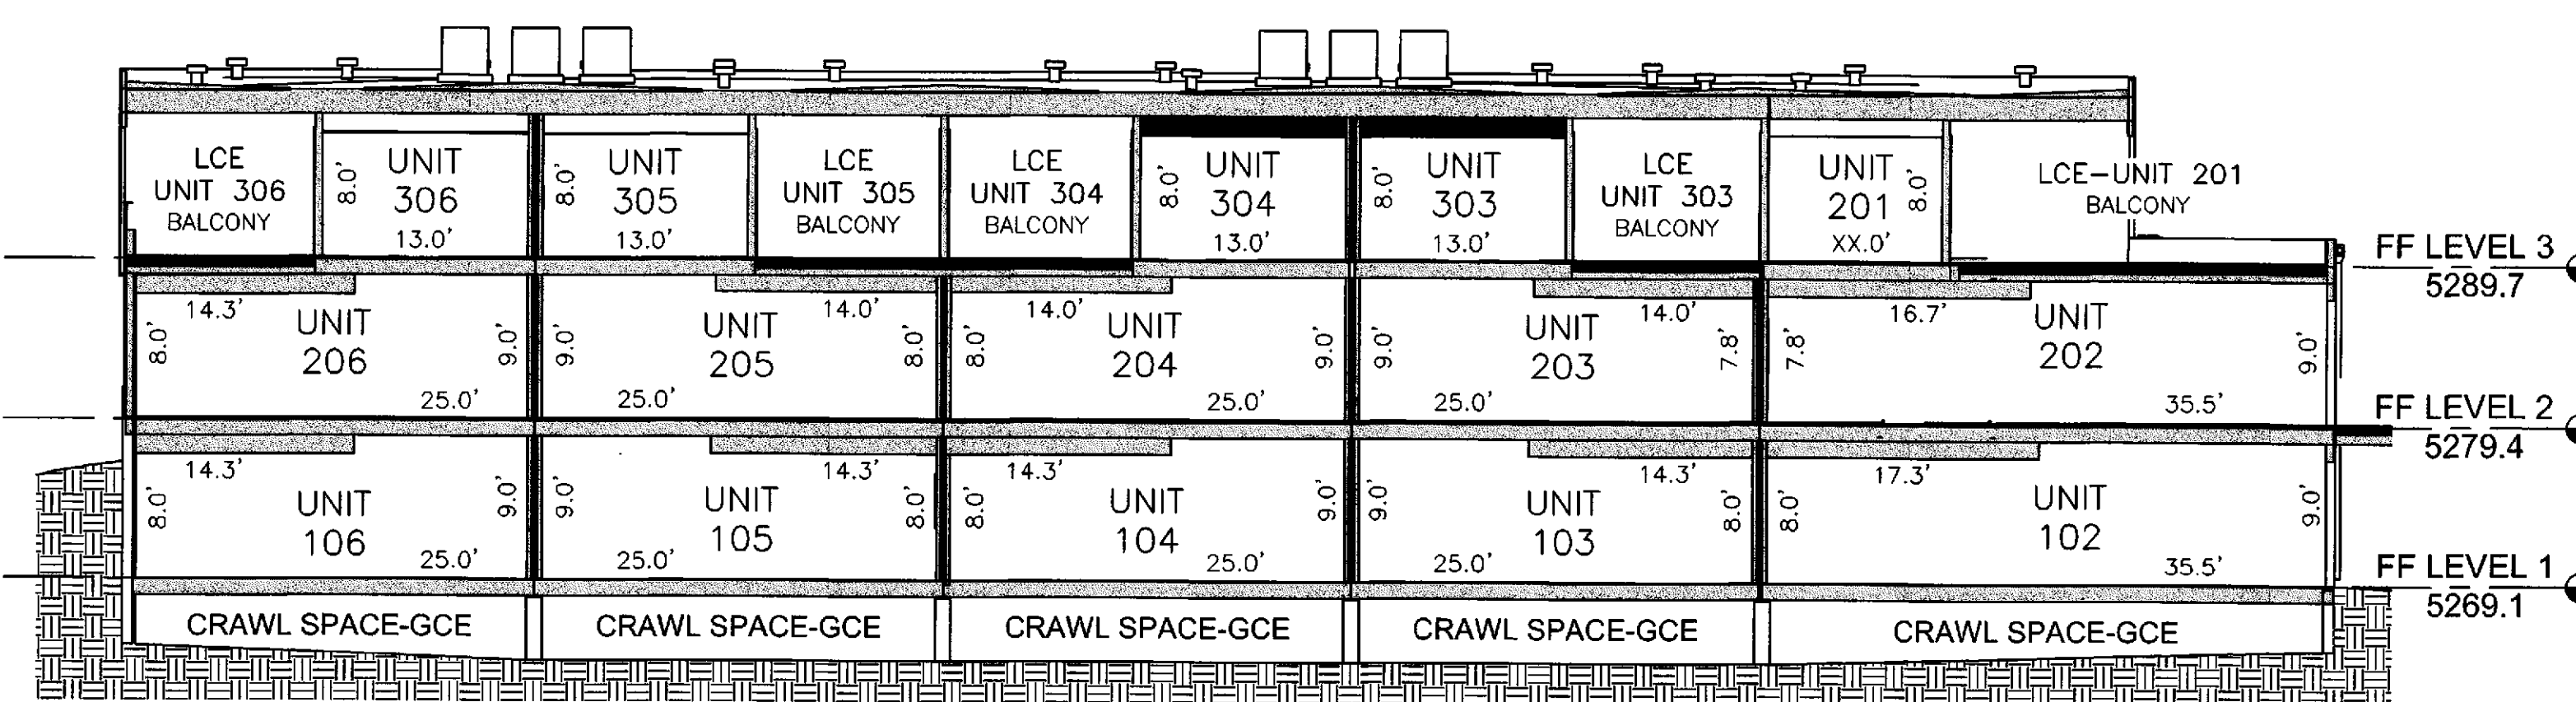
**BUILDING D**

NORTH-SOUTH CROSS-SECTION LOOKING EAST  
(NO INTERIOR WALLS SHOWN)

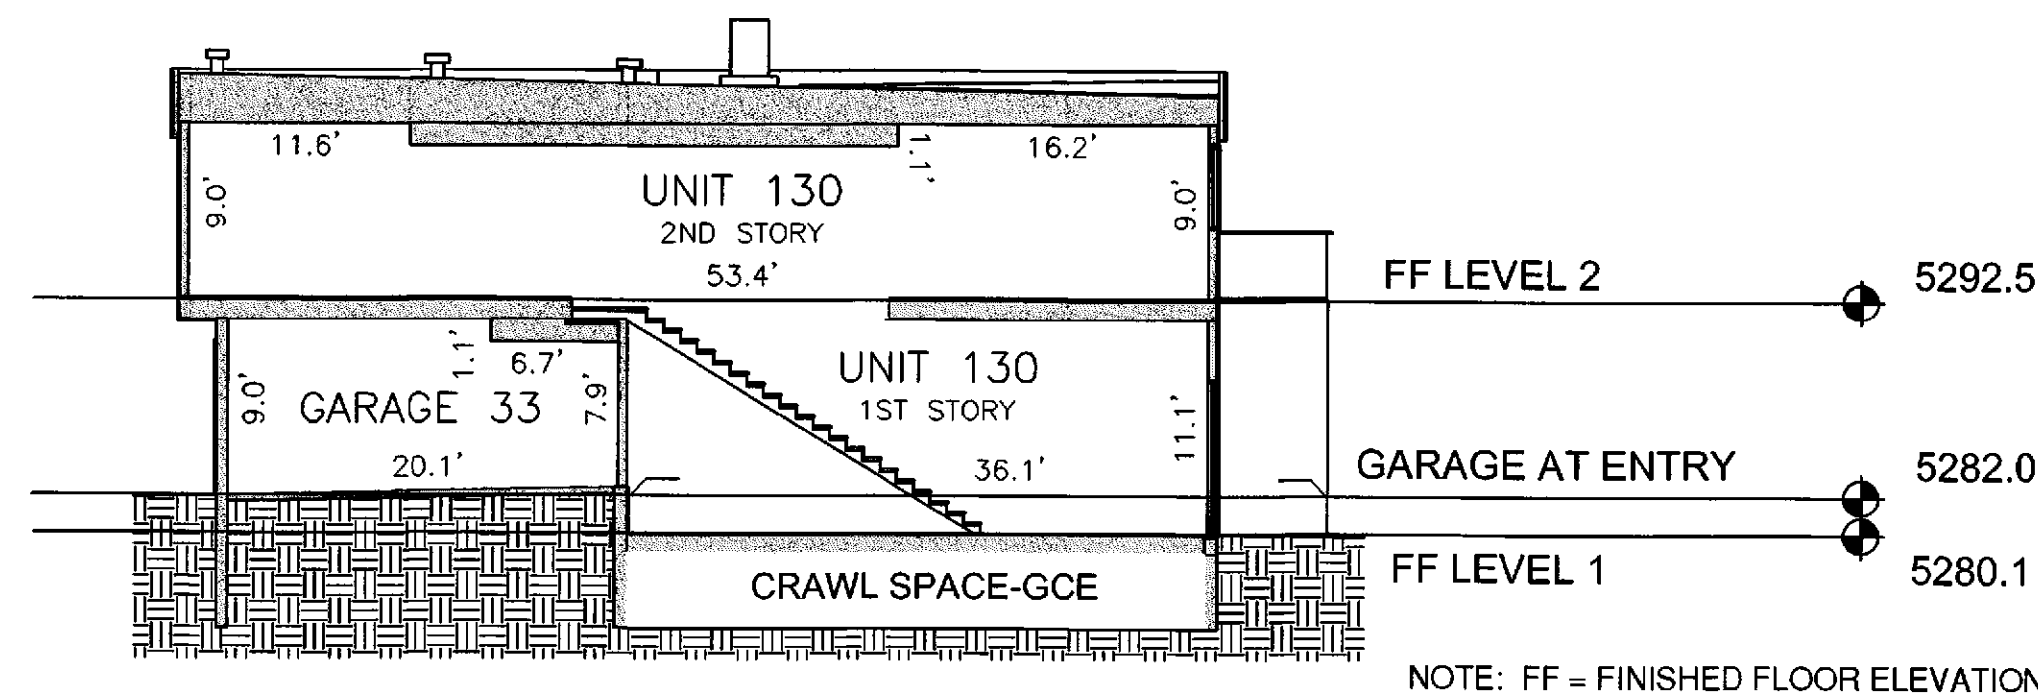
**BUILDING E**  
TYPICAL NORTH-SOUTH CROSS-SECTION, LOOKING EAST  
(NO INTERIOR WALLS SHOWN)

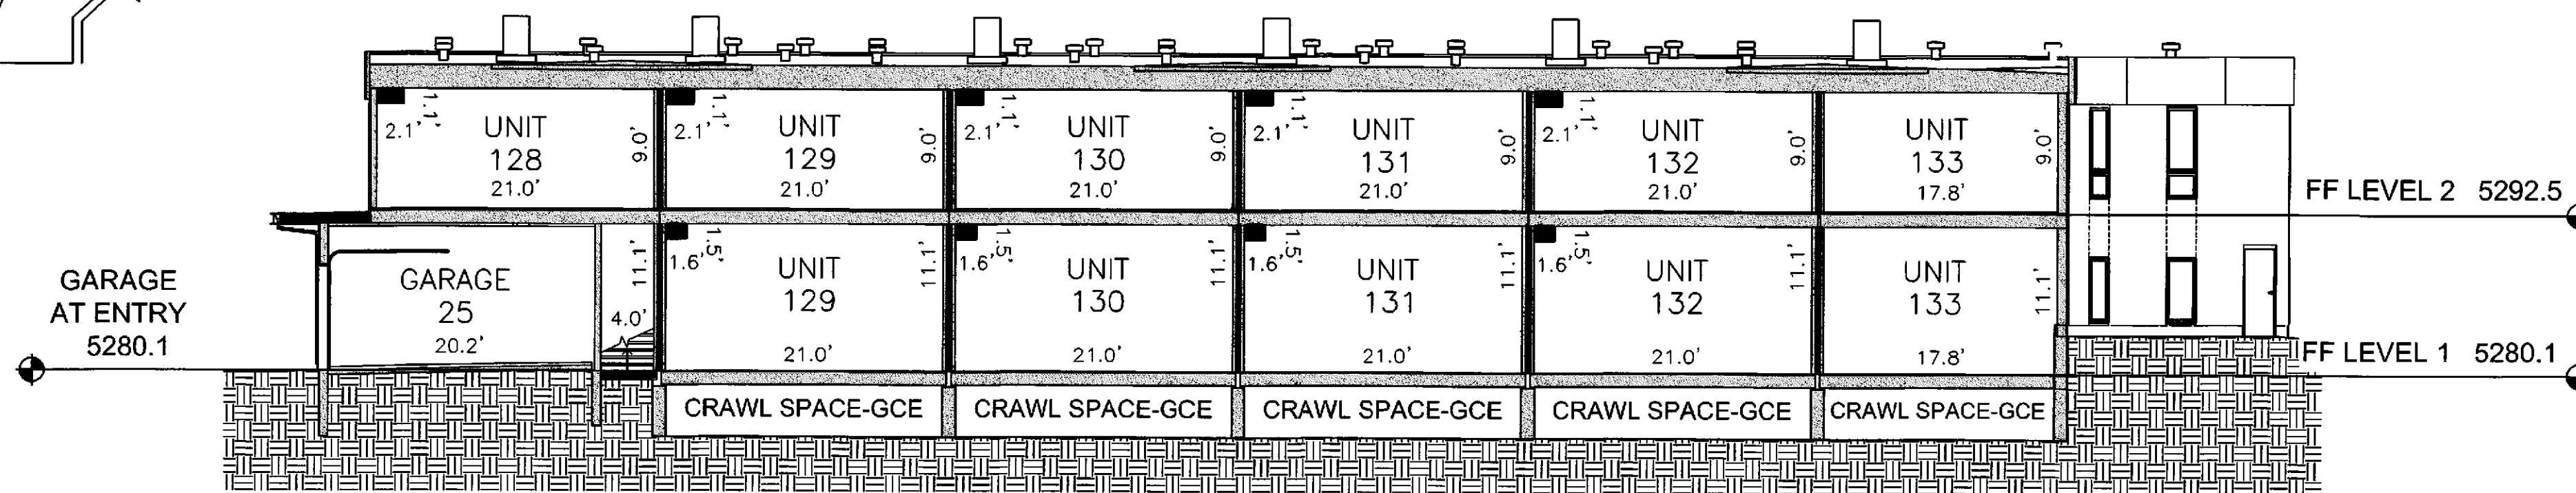
**BUILDING E**  
WEST-EAST CROSS-SECTION  
LOOKING NORTH (NO INTERIOR WALLS SHOWN)
